# RESEARCH MEMORANDUM

DITCHING INVESTIGATION OF A  $\frac{1}{14}$  - SCALE MODEL

OF THE NORTHROP C-125 AIRPLANE

By Lloyd J. Fisher and John O. Windham

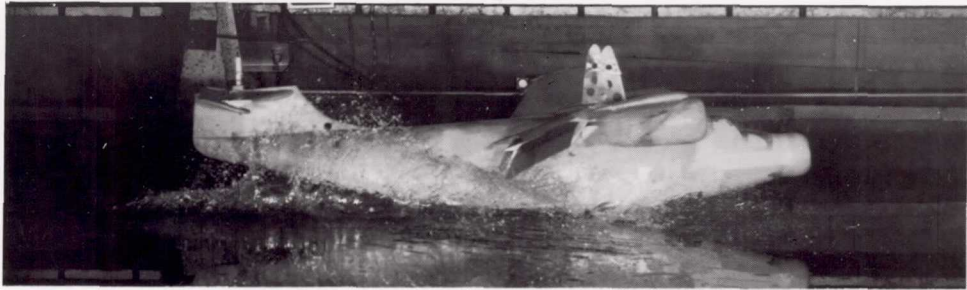
(b) Landing gear removed.

model was tested with the landing gear removed, it did not dive (fig. 5). In the undamaged condition the model trimmed up on contact with the water and made a long smooth run. When damage was simulated the runs were shorter and the model porpoised or ran deeply in the water, depending on the extent of damage. If the main landing gear could be made jettisonable or retractable, the ditching characteristics of the airplane would be greatly improved.
